Cracked Bearing Race Detection in Wind Turbine Gearboxes

[Note: This article is based on a paper presented at the China Wind Power 2010 conference in Beijing, China in October 2010.]

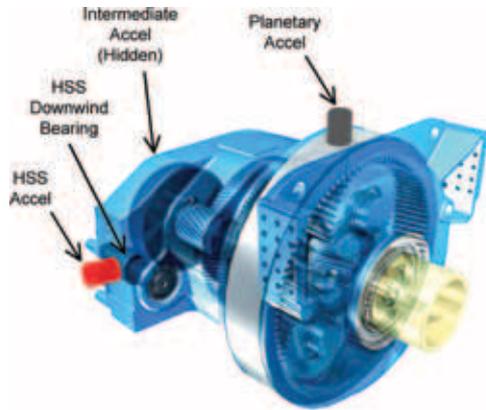
In this case history, we will be discussing enveloped data from the gearbox high-speed shaft (HSS) accel (Figure 1). The diagnostic process utilized the high sensitivity provided by acceleration enveloping, so we will begin with a brief review of the enveloping process.

Figure 1: Wind turbine gearbox, viewed from the main rotor side. The high-speed shaft downwind bearing (HSS DW) and accel locations are shown. The high-speed accel location used for this case history is shown in red.

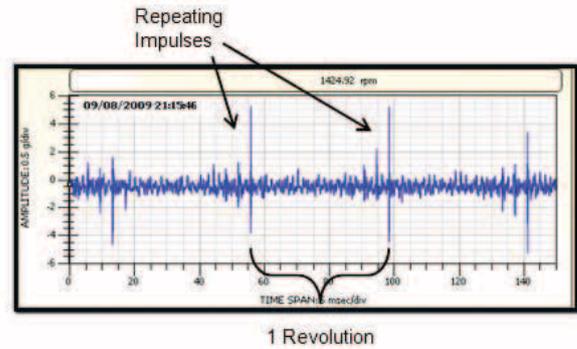
Figure 2: High-speed acceleration waveform from ADAPT.wind software showing periodic impulse patterns. The patterns repeat once every revolution.

After deployment of the ADAPT.wind monitoring systems, some interesting vibration signatures were observed on a few gearboxes. On one, the timebase waveforms from the high-speed gearbox accelerometer showed a repeating pattern of symmetric impulses of very short duration (Figure 2). This waveform was captured in September 2009. The waveform shows a pattern of three impulses that increase and decrease in amplitude. As the inner race rotates through one revolution, the defect moves in an out of the radial load zone of the bearing, producing the long-wave modulation pattern. As it enters the load zone, the defect encounters successive rolling elements (cylindrical elements in this case). Each defect/element encounter produces an impulse in the waveform (the short period modulation pattern). The impulses increase in amplitude until a maximum is reached when

the defect is approximately aligned with the radial load direction in the bearing. Then, as the defect begins to leave the load zone, the impulses rapidly die away. This basic pattern is repeated once per revolution of the high-speed gearbox shaft and is highly suggestive of a single, inner-race defect in a bearing on that shaft.

Initially, the extremely narrow, sharp spike appearance in Figure 2 suggested an electrical noise problem on this accelerometer channel. To verify the data quality, several of the "spikes" in the signal were zoomed. Figure 3 shows a zoom from a similar waveform that has been exported and high-pass filtered at 5 kHz using MATLAB® software. The spike is clearly an impulse/response signature indicating mechanical vibration, not electrical noise. The vibration occurs at the "carrier" frequency that will be used for envelope demodulation. The enveloping bandpass filter was set from 4 kHz to 10 kHz, so this 5 kHz high-pass filtered plot shows approximately what the enveloping algorithm would see.

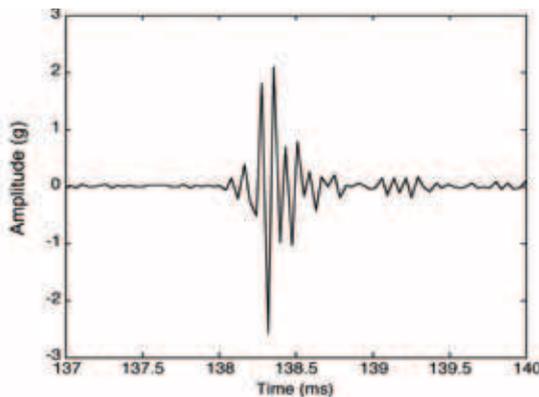
Figure 3: Zoom on a typical spike showing mechanical impulse/ response behavior.

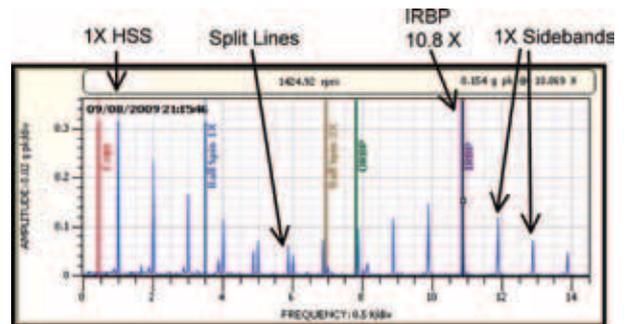
Figure 4: Acceleration envelope spectrum of waveform in Figure 2 (September 2009). The key bearing fault frequency lines are overlaid on the plot. The IRPB fault line is a perfect fit to the data. The split lines show that the two harmonic series are separated. Data processed in ADAPT.wind software.

Enveloped spectra from this accelerometer display a rich harmonic series (Figure 4). This figure shows enveloped frequencies in orders of high-speed shaft (HSS) speed. The lowest fundamental corresponds to the HSS speed (1X HSS), and there are several harmonics. The next major feature is the inner-race ball pass (IRBP) frequency at 10.8X. This frequency agrees with the theoretical IRBP defect frequency for the high-speed downwind radial

bearing. A series of 1X sidebands are present on both sides of the central fault frequency line. (Most often, sidebands occur in spectra because of amplitude modulation of vibration happening at the center frequency.) The IRBP frequency at 10.8X is close to a harmonic of HSS speed at 11.0X, so at first glance, all the lines in the spectrum appear to be equally spaced harmonics of 1X. Close inspection shows that there really are two distinct harmonic series, one series based on 1X, and the other based on 1X sidebands from 10.8X. You can clearly see that the two families of spectral lines nearly overlap, and that separation is visible in the split lines near 5X and 6X.

Given the data so far, we concluded that a single defect existed on the HSS downwind radial bearing inner race. The extreme narrowness of the impulse/response signatures led us to suspect that the defect was a crack in the inner race; we reasoned that a broader spall would likely have produced a less well-defined impact signature. But at this time, because the overall amplitude of vibration was only 5 g, we recommended that the operator wait and watch. This would allow us to see how quickly the damage evolved. If it increased significantly, we would recommend shutting down the turbine.

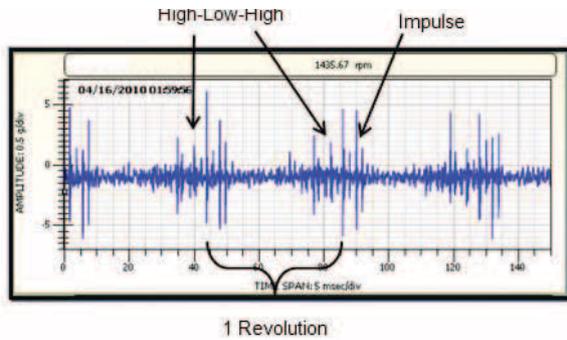
Figure 5: Data from the same bearing as Figure 2, but several months later. The vibration signature has become more complex.

Although the amplitude of vibration remained about 5 g, there were two primary differences between the data in Figure 5 and the data in Figure 2. First, the impulse pattern in Figure 5 shows a repeating high-low-high impulse pattern with each revolution. This differs from the steadily rising amplitude pattern in Figure 2. Secondly, there is another set of lower-amplitude impulses that are offset by less than the element passage period from the larger set. This "double impulse" set appears at the same place every revolution. These changes suggest that more damage has developed on the inner race; the second change suggests that some of the additional damage is smaller than the original damage we observed before.

The impulse signatures still remained very narrow, and we suspected that a second crack had developed in the inner race. Still, at this time, overall vibration remained only about 5 g, so a decision was made to keep watching.

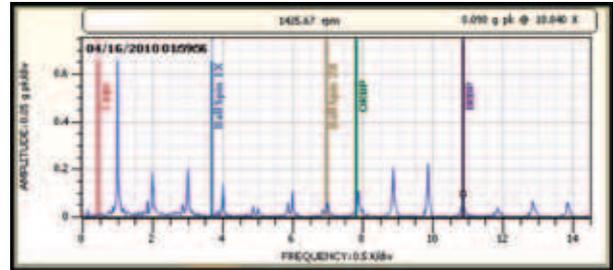
Figure 6: Data from April 2010. Compare to Figure 4. The amplitude of the IRBP line is lower, while the 1X line amplitude is higher.

The envelope spectrum also shows some interesting changes. The 1X line has *increased* in amplitude, while the IRBP line has *decreased* (Figure 6, compare to Figure 4). The increase in 1X modulation has also increased the IRBP 1X sideband amplitude. This is interesting because it shows that more damage can actually reduce the IRBP amplitude.

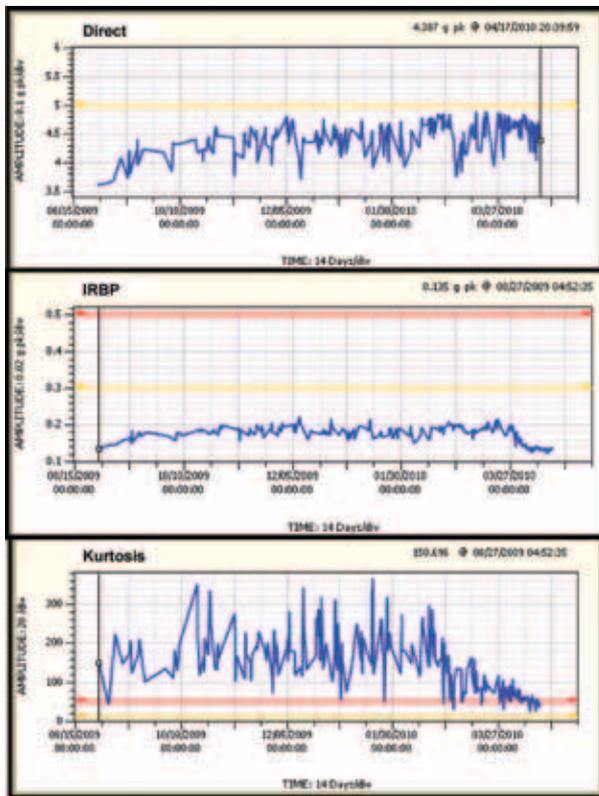
Figure 7: Trend plots from August 2009 to April 2010. Direct vibration (top) increases, but IRBP frequency amplitude (middle) and kurtosis (bottom) decrease near the end of the period.

Trends of direct vibration amplitude, IRBP amplitude, and kurtosis also changed over this period (Figure 7). Direct vibration slowly increases; this is a measure of the impulse amplitude we see in the timebase plots. The middle plot is the amplitude of the IRBP line in the envelope spectrum; it is approximately constant until it drops off near the end of the period. The kurtosis also declines near the end.

While the decline in IRBP is somewhat puzzling, the decline in kurtosis is caused by the larger number of impulse events in the waveform; in other words, the average signal excursion has increased. This reduces kurtosis, which is very sensitive to outliers. When everything is an outlier, then the outlier becomes the norm.

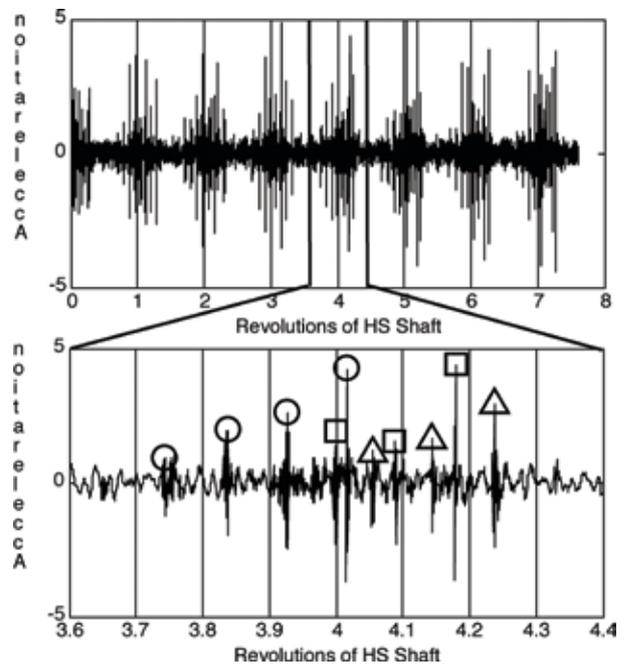
Figure 8: HSS accelerometer waveform from the second turbine gearbox. The circular, square, and triangular marks highlight three distinct patterns of fault induced impulses. This pattern suggests at least three separate inner race faults.

In April 2010, another turbine was commissioned. This turbine was identical in every way to the first one. The HSS accelerometer data showed similar behavior to the first turbine (Figure 8, upper). This waveform shows a similar, very complex series of very narrow impulses.

The impulses appear to form three distinct repeating groups (these are marked in the lower figure with circles, squares, and triangles); in each group, impulses are separated by the IRBP fault period (1/10.8X = 0.093 revolutions) for the HSS downwind radial bearing. All of the impulses disappear and reappear once per revolution of the high-speed shaft. We concluded that at least three different faults on the inner race of the bearing were repeatedly passing through the bearing load zone. Note that the impulse amplitudes are also 4 to 5 g. Because there were so many indications of damage, we felt that there was a very good chance that this bearing would have visible damage that could confirm the diagnosis. This bearing is located in an accessible part of the gearbox, so the operator decided to replace this bearing, work that could be done up tower without a crane.

In May 2010 the bearing was replaced, and the original was inspected. We discovered four radial cracks in the inner race that extended some distance axially across a significant part of the race (Figure 9 shows the largest of them). None of these cracks had propagated all the way through the race, so there was some remaining useful life in the bearing.
